# Substantial Changes Follow 2-Year Dormancy of Wingfield Pines Abandoned Mine Drainage Remediation System

By Garrett Struble

## ABSTRACT

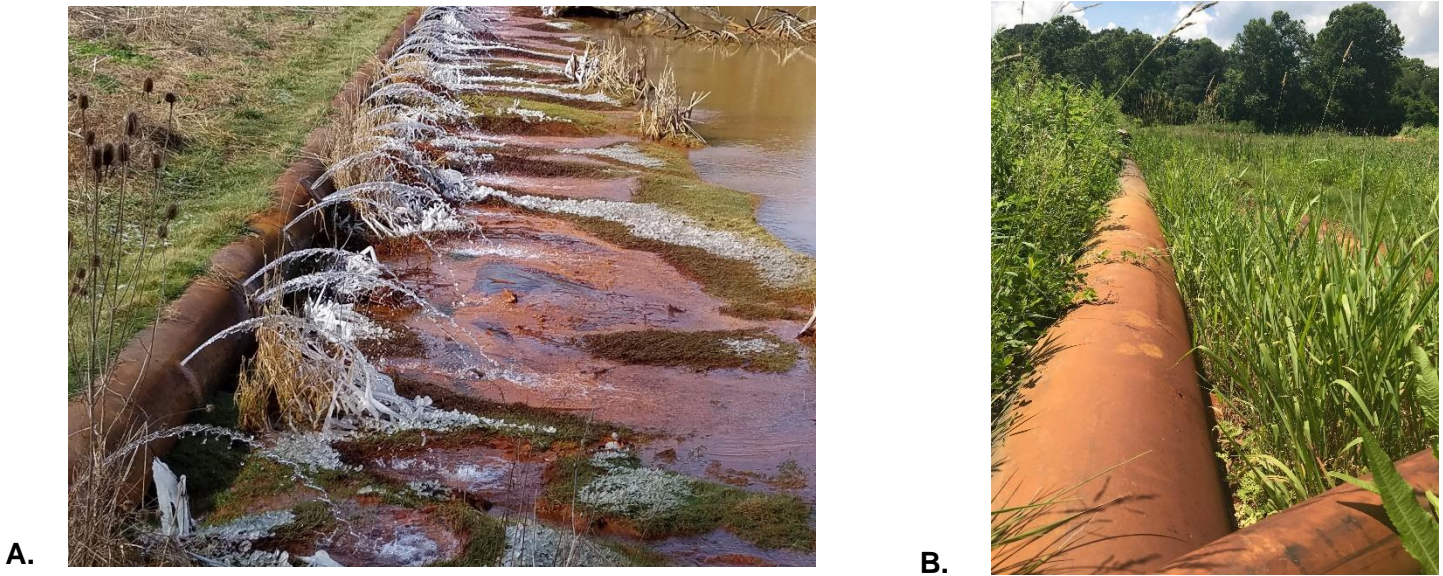
On November 6, 2017, ALT staff at Wingfield Pines noticed that the system's fountain pipe was no longer running (**Figure 1A&B**). The fountain pipe usually feeds the system and exposes ferrous iron ( $\text{Fe}^{2+}$ ) to oxygen to form ferric ( $\text{Fe}^{3+}$ ) iron precipitants<sup>1</sup>. Further investigation attributed the system's failure to a major breach in the mine cavern, causing the AMD to bypass the system<sup>1</sup>. ALT staff suggested that multiple flash flood events in the McLaughlin Run watershed around the time of the blowout likely acted to catalyze the geologic event<sup>1</sup>. Immediately after the blowout was discovered, ALT staff began their proposal to contain AMD and repair the system<sup>1</sup>. Repair of the system would prove difficult, however, due to the magnitude and location of the blowout.

**Figure 1. Fountain Pipe which Feeds AMD System. (A)** The fountain pipe which feeds the passive remediation system and oxidizes ferrous iron in AMD effluent is shown before the system's failure in November 2017. Photo taken 17 February 2017 by Michelle Valkanas, Ph.D. candidate; Duquesne University. **(B)** After the system's failure, the fountain pipe which feeds pond 1 stopped flowing. The abundance of plant life which appeared in the system during the ~2-year repair is shown. Photo taken 26 June 2019 by Garrett Struble.

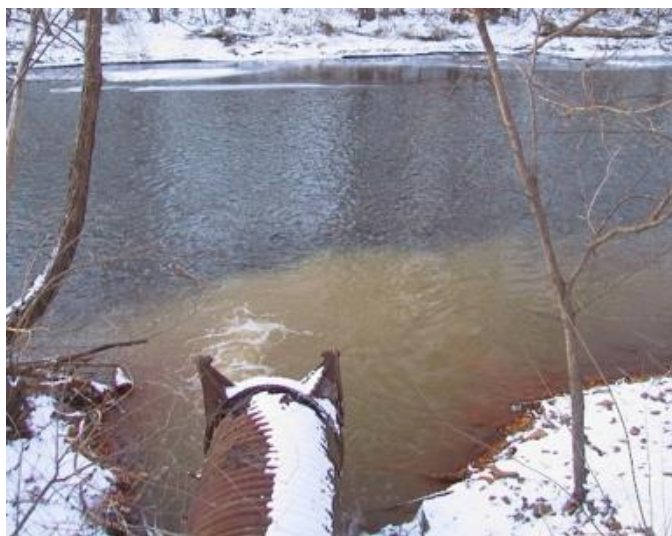
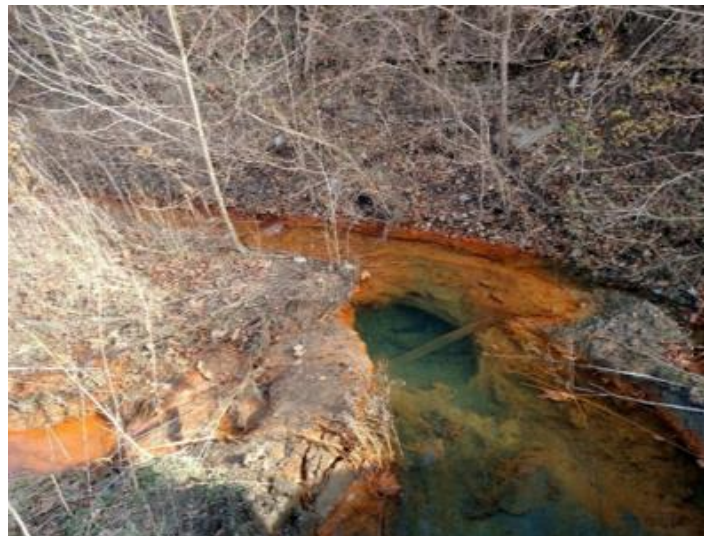
Following the major rupture to the mine cavern in November 2017, AMD bypassed the 20-acre passive remediation system, flowing directly into Chartiers Creek at rates of ~2,000 gallons/min (**Figure 2A&B**)<sup>1</sup>. Due to the nature of the sub-surface fracture, the multi-step repair took nearly 2 years to complete—leaving the system dormant. Until the system's re-opening in September 2019, iron-rich AMD flowed directly into Chartiers Creek as it did pre-2009 (**Figure 2B**)<sup>1</sup>. Multiple flooding and severe weather events, which increased in intensity in 2018, paired with the effluent of the AMD breach caused the PVC effluent pipe to become eroded. The result was an iron-laden stream bed connecting the final holding pond directly to Chartiers Creek (**Figure 3 A&B**). Failure of the passive coal mine remediation system at Wingfield Pines, followed by its lengthy ~2-year construction, illustrate the long-lasting effects of previous unsustainable land use.

**Figure 2. Mine Breach Photographed Shortly after Rupture. (A)** Non-remediated AMD can be seen flowing into Chartiers Creek before the system's installation. Wingfield Pines AMD discharge has an orange color due to high iron content. Photo taken 2008. **(B)** The blowout hole which caused the breach of the passive remediation system spews AMD. Photo taken 6 November 2017. Photos by Emilie Rzotkiewicz, Vice President of Land Resources; Allegheny Land Trust

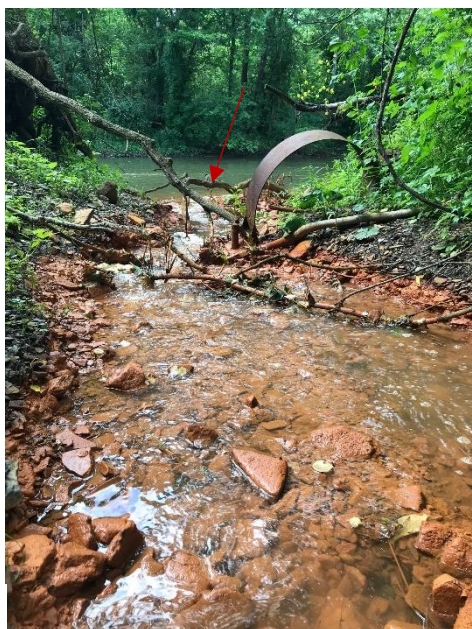
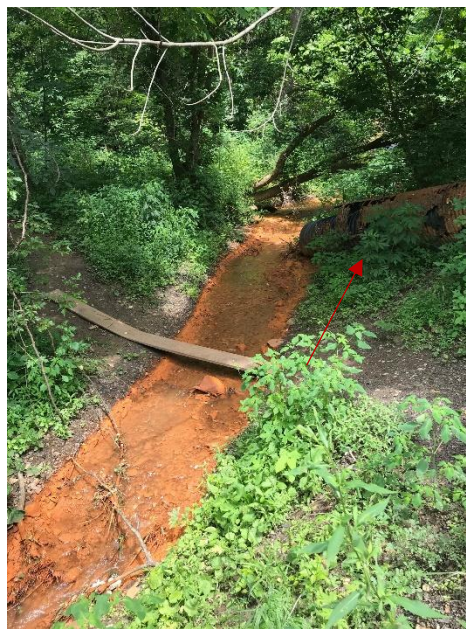
**Figure 3. Discharge of AMD into Chartiers Creek After System Breach. (A)** Multiple flooding and severe weather events paired with the effluent of the AMD breach led to a wash out of the system's effluent pipe, which previously fed Chartiers Creek (red arrow). **(B)** Debris from the remnants of a land bridge with sub-surface PVC drainage pipe can be seen scattered on the right side of the riverbank (red arrow). Photos taken 26 June 2019 by Garrett Struble.

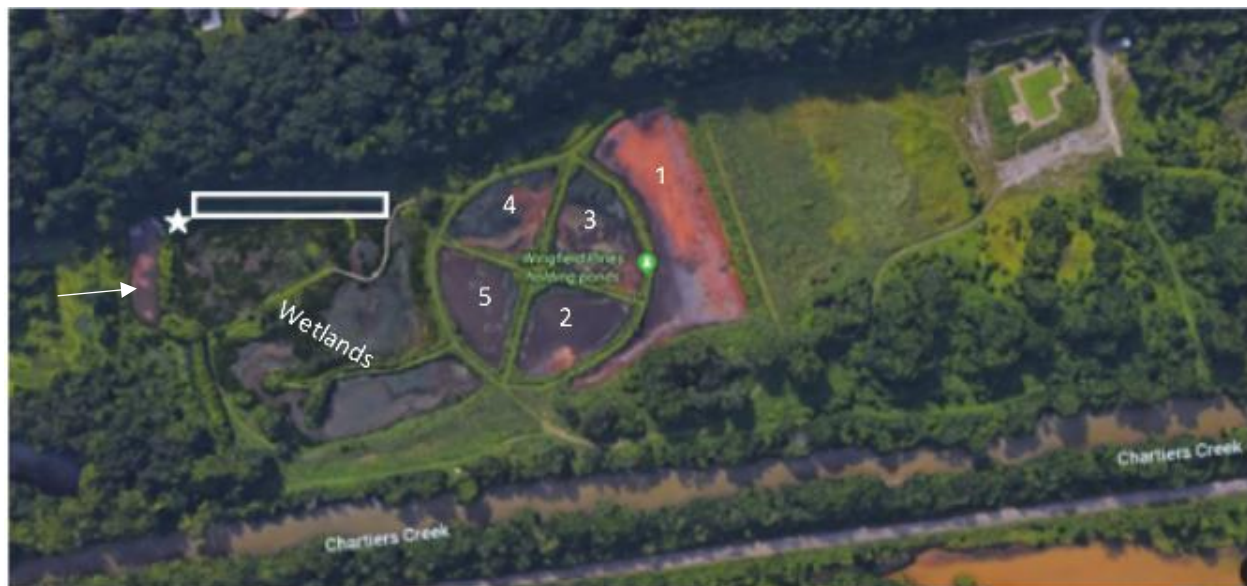
**Figure 4. Location of Mine Cavern Breach at Wingfield Pines.** The surface location of the mine breach is labelled with a star icon. AMD flowed into a small retention pond (white arrow) that drains into Chartiers Creek after the system's wetlands. The portion of the wetlands removed to allow access to the blowout is denoted with a white rectangle. Locations of the ponds and wetlands are labelled. Image retrieved from Google Earth on 30 November 2019.

Repair of the system occurred in several stages: redirecting mine flow, installing an emergency pump, drilling around the fracture and subsequently sealing with a combination of [polyurethane foam](#) (Sub technical) and [cement](#) (Howard Cement)<sup>6-7</sup>. The mine fracture occurred on the high wall just before the discharge of the system's wetland into a final holding pond (**Figure 4**) before meeting Chartiers Creek. Due to the location of the fracture, a portion of the wetlands bordering the system was replaced with limestone gravel in order to allow the passage of construction vehicles (**Figure 4**). The disturbed portion of the wetlands does not receive AMD and was primarily composed of *Impatiens capensis* (spotted jewel weed) and *Sparganium americanum* (bur reed).

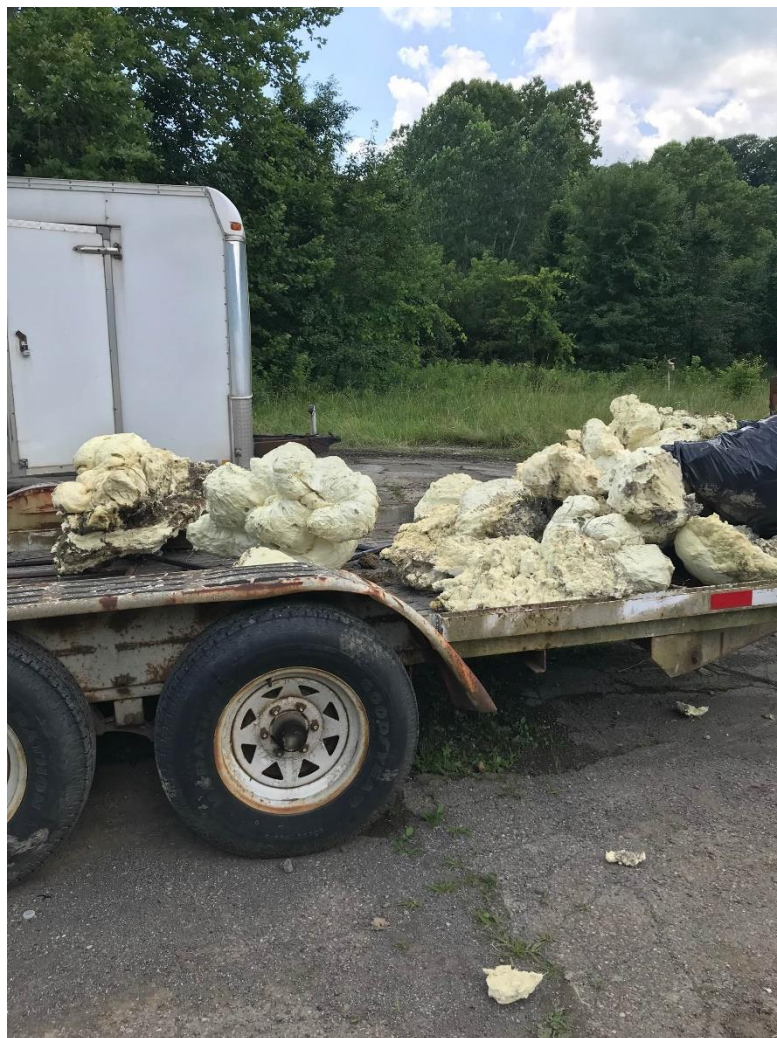
**Figure 5. Temporary Foam Sealant Used in Repair.** Excess foam sealant used to seal the AMD breach can be seen on a trailer before removal from the property. Photo taken 26 June 2019 by Garrett Struble.

To achieve this feat, several staging areas and heavy-duty construction equipment were required to drill access holes to the mine cavern breach, install underground fail-safe/redirecting piping, and inject temporary sealant. ALT hired independent contractors Sub-Technical and Howard Cement to inject foam sealant and cement, respectively. Sub-Technical originally estimated that 600lbs of polyurethane foam sealant was needed to seal the mine blowout. Due to the unexpected extent of the fracture, 11,000lbs of polyurethane was actually required to produce the seal. Excess foam sealant, which overflowed from injection holes, is pictured in **Figure 5.**

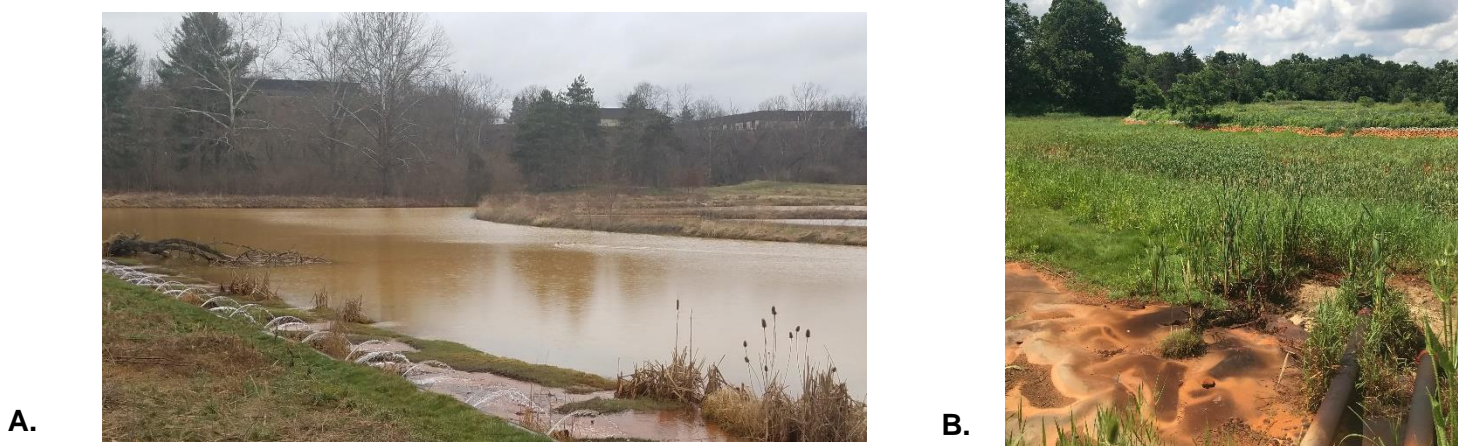
**Figure 6. Pond 1 Before and After System Failure. (A).** Pond 1 photographed before the system's failure shows functional fountain pipe and absence of plant-life. Photo taken 27 February 2017 by Michelle Valkanas, Ph.D. candidate; Duquesne University. **(B)** Pond 1 photographed during the system's repair shows abundance of plant cover in dry ponds. Photo taken 26 June 2019 by Garrett Struble.

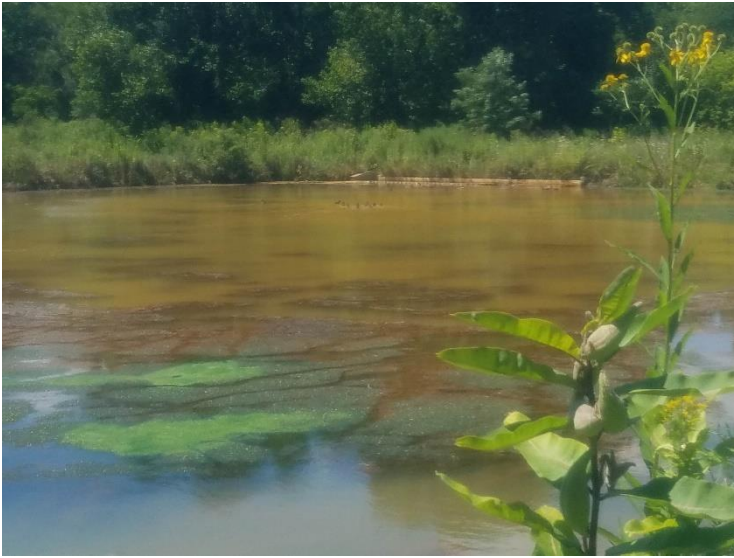
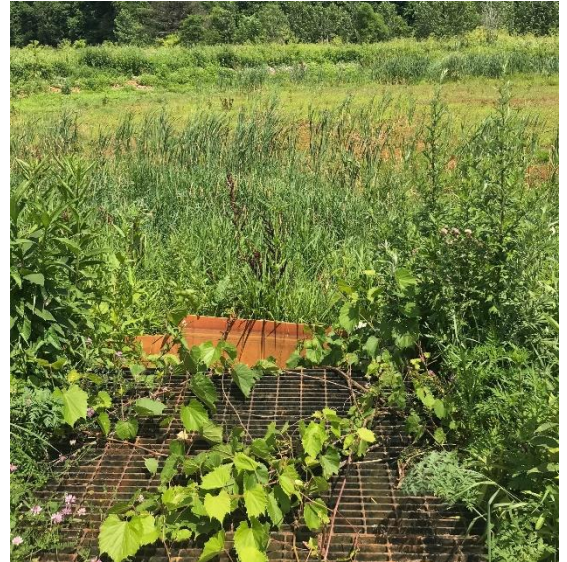
**Figure 7. Pond 2 Before and After System Failure. (A)** Pond 2 photographed before the system's failure shows absence of plant-life. Photo taken 8 August 2017 by Michelle Valkanas, Ph.D. candidate; Duquesne University. **(B)** Pond 2 photographed during the system's repair shows abundance of plant cover in dry ponds. Photo taken 26 June 2019 by Garrett Struble

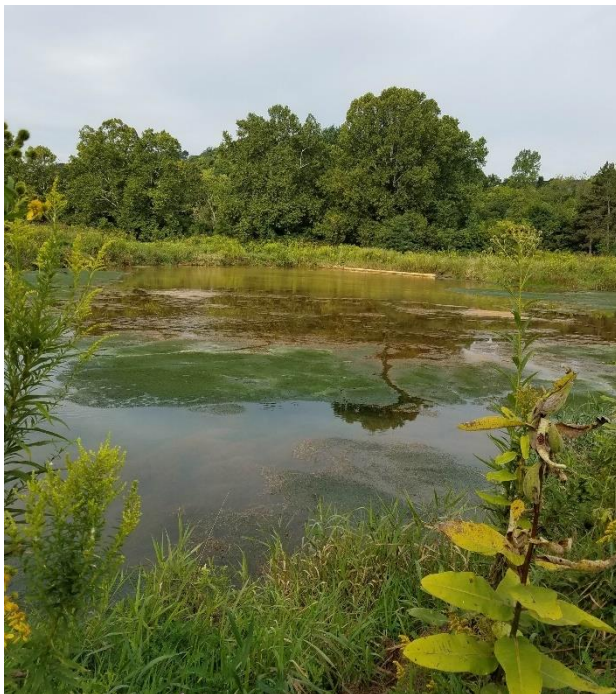
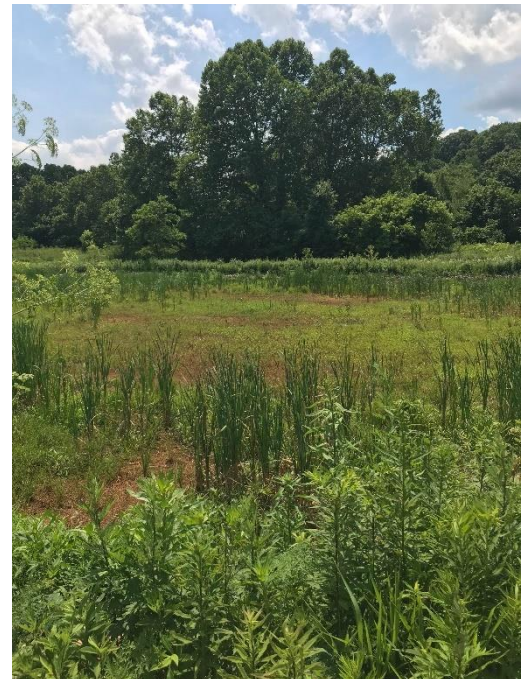
**Figure 8. Pond 3 Before and After System Failure. (A)** Pond 3 photographed before the system's failure shows absence of plant-life. Photo taken 29 August 2017 by Michelle Valkanas, Ph.D. candidate; Duquesne University. **(B)** Pond 3 photographed during the system's repair shows abundance of plant cover in dry ponds. Photo taken 26 June 2019 by Garrett Struble

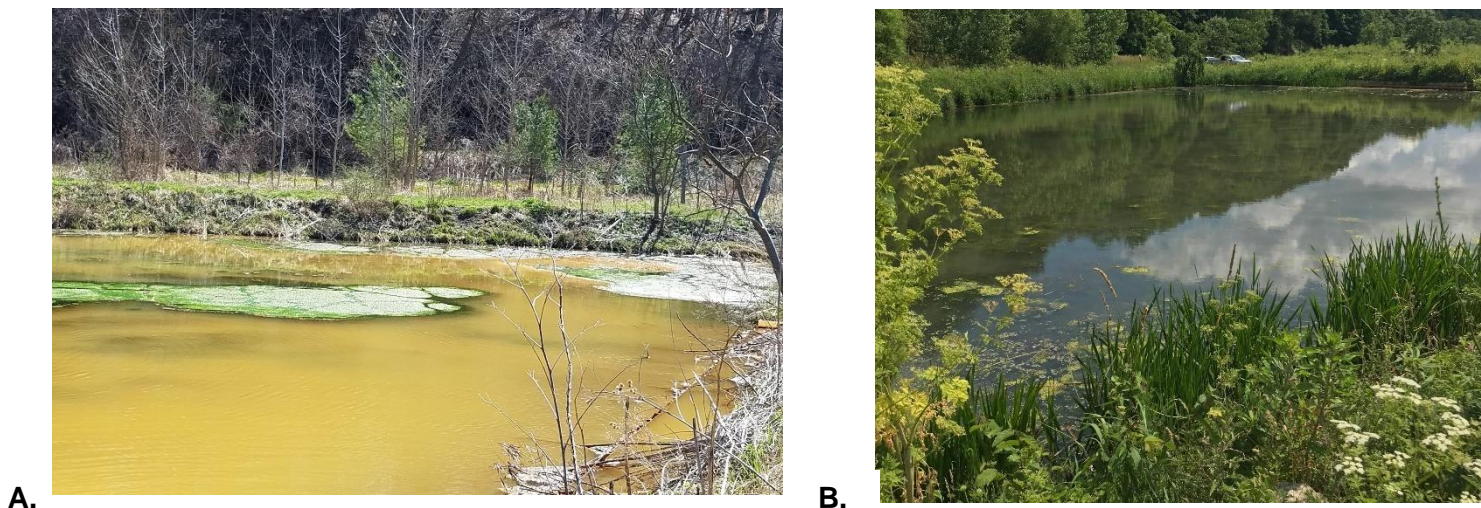
During the summer months of 2019, pond 4 acquired a relatively high temperature (~28°C), a distinct cyanobacteria/alga layer, and frequent sightings of *Chrysemys picta* (painted turtle), *Anas platyrhynchos* (mallard), *Ardea Herodias* (great blue heron), various snakes native to PA, and various *Lithobates* (American water frogs) in and around the pond. Additionally, pond 4 became more basic (lab pH ~7.7) than when the system is operating (lab pH ~6.5)<sup>3</sup>.

**Figure 9. Pond 4 Before and After System Failure. (A)** Pond 4 photographed before the system's failure shows absence of plant-life. Photo taken 29 March 2017 by Michelle Valkanas, Ph.D. candidate; Duquesne University. **(B)** Pond 4 photographed during the system's repair shows maintained absence of plant cover due to maintained fill. Photo taken 26 June 2019 by Garrett Struble

Pond 4 remained clear of vegetation except around its shore as a result of remaining filled during the system's repair (**Figure 9A**). The impact that these changes have had on the system from a physical standpoint alone will likely prove significant. During the ~2-year dormancy, pond 4 was also exposed to vastly different redox conditions than ponds 1, 2, 3, and

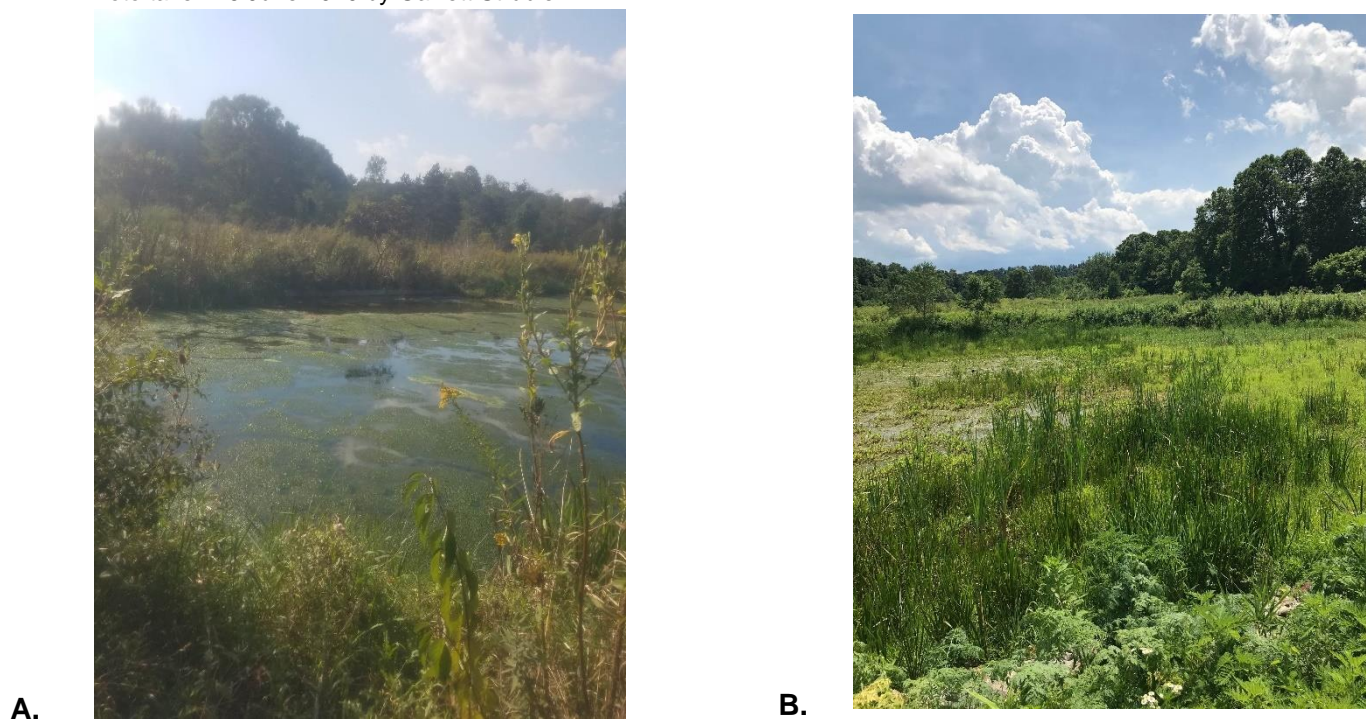
**Figure 10. Pond 5 Before and After System Failure. (A)** Pond 5 photographed before the system's failure shows absence of plant-life. Photo taken 27 September 2017 by Michelle Valkanas, Ph.D. candidate; Duquesne University. **(B)** Pond 5 photographed during the system's repair shows abundance of plant cover in dry ponds. Photo taken 26 June 2019 by Garrett Struble

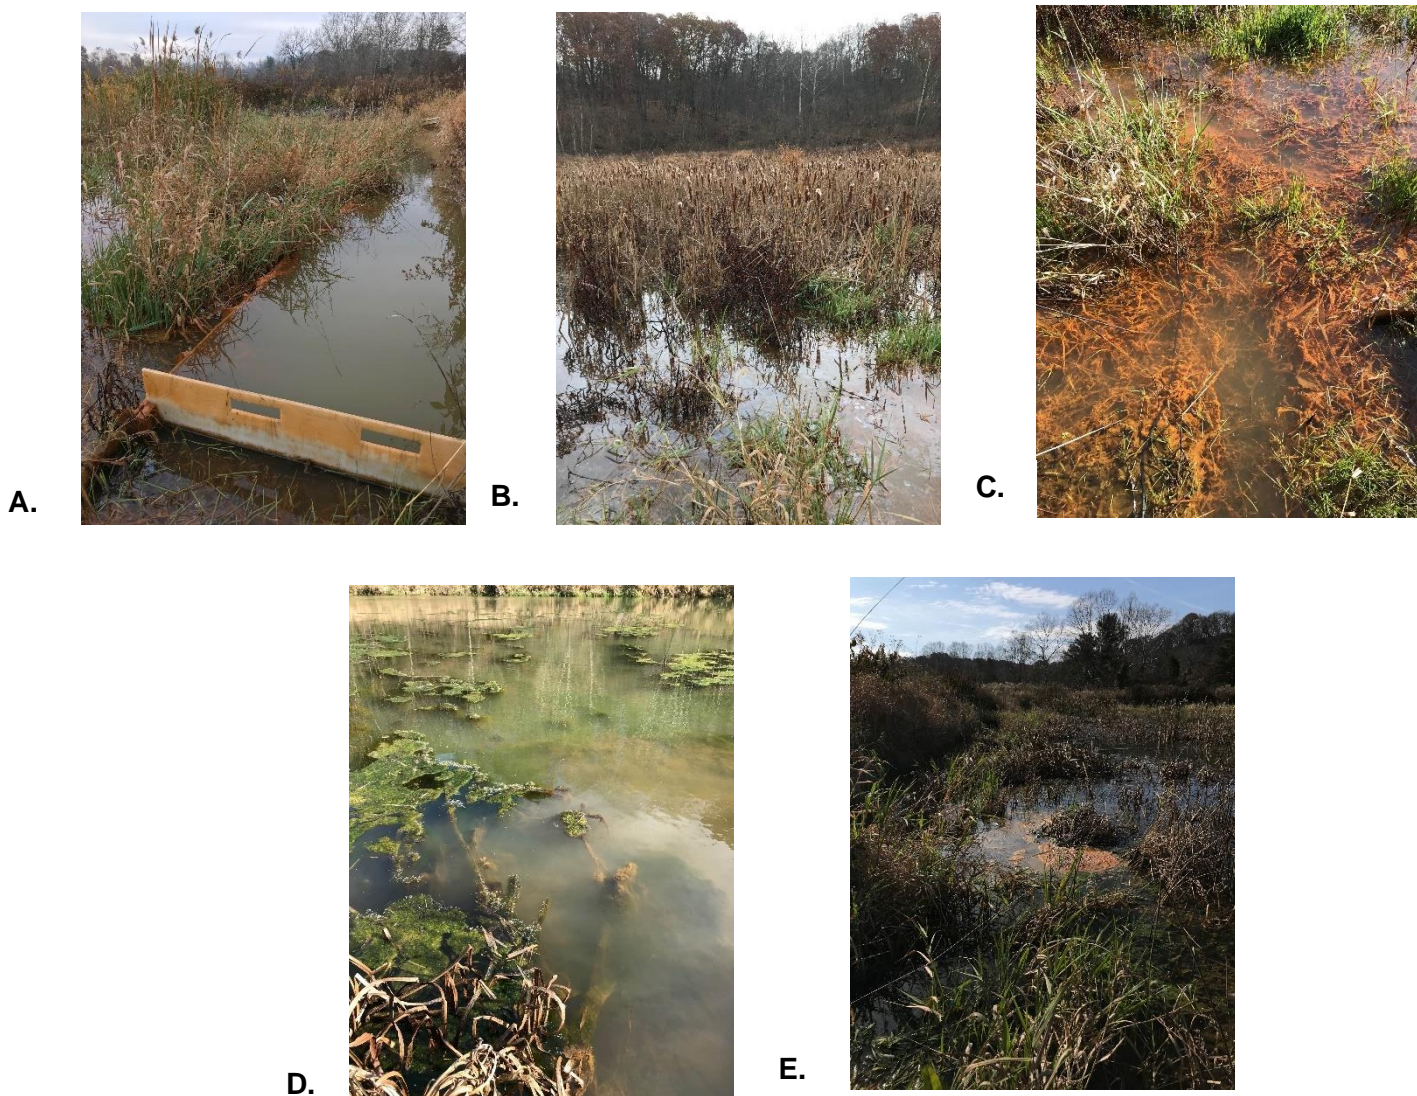
**Figure 11. System Appearance After the Repair.** **(A)** Vegetation surrounding the influent trough of pond 2. Photo taken 21 November 2019. **(B)** Dense vegetation of *Typha* in pond 3 following repair. Photo taken 21 November 2019 **(C)** Iron plaque on vegetation observed in ponds following repair. Photo taken 10 November 2019 **(D)** Cyanobacteria/algae mat in pond 4 following repair. Photo taken 10 November 2019. **(E)** Dense cluster of grassy vegetation holds iron plaque in pond 5 following repair. Photo taken 10 November 2019.
